Figure 12: Typical Window and Door Casing Detail

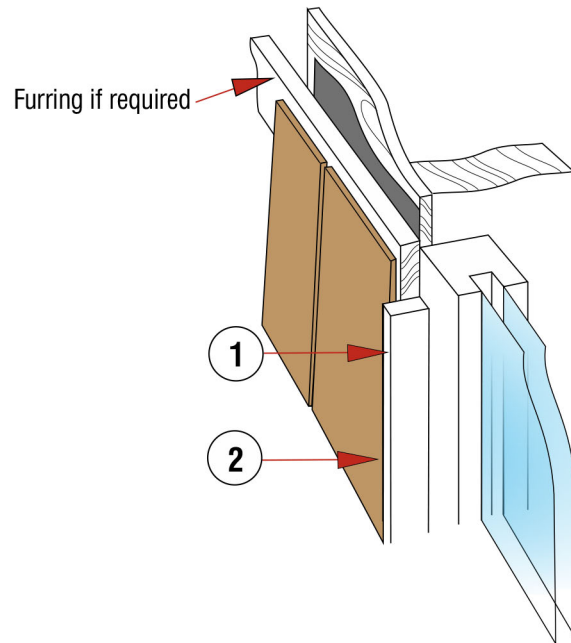
1. Apply new casing to bring Certi-label® Western Cedar shingles or shakes flush with surface
2. The integrity of the original flashing is to be utilized. Additional trim is considered to be decorative only. If the original window does not have good structural integrity, it must be removed and a new one installed. New casings are to be installed as part of proper wall construction as shown throughout this manual.
