IMPACT SECURITY, LLC ACOUSTICAL PERFORMANCE TEST REPORT

ASTM E90 SOUND TRANSMISSION LOSS TESTING ON A DEFENSELITE PRO, FIXED WINDOW

N2700.01-113-11-R1

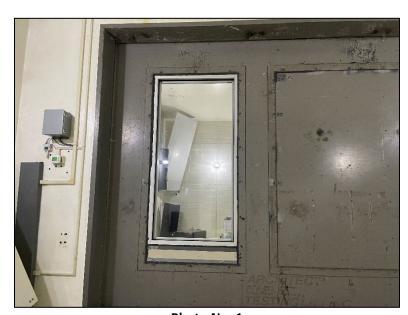
Photo No. 1
Interior View of Installed Test Specimen

The specimen plug was removed from the filler wall assembly. The specimen was placed on an isolation pad in the test opening. Duct seal was used to seal the perimeter of the specimen to the test opening on both sides. The interior side of the specimen, when installed, was approximately 1/4" from being flush with the receive room side of the filler wall. A stethoscope was used to check for any abnormal air leaks around the test specimen prior to testing. Operable portions of the test specimen, if any, were cycled at least five times prior to testing.

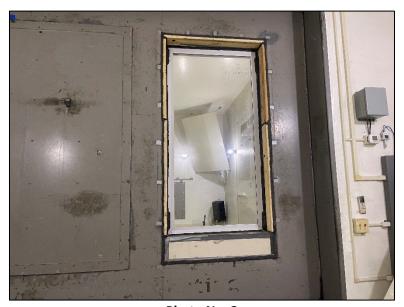
Photo No. 2 Source Room View of Installed Test Specimen

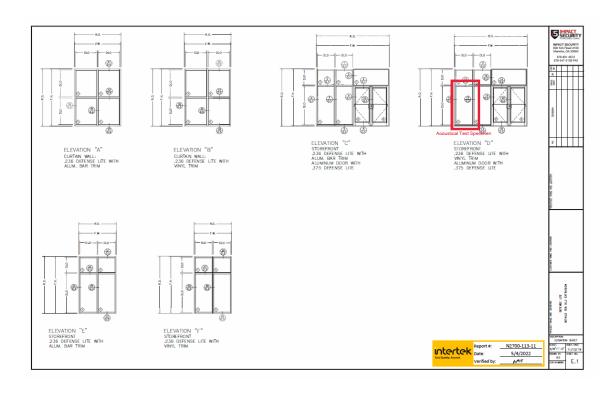
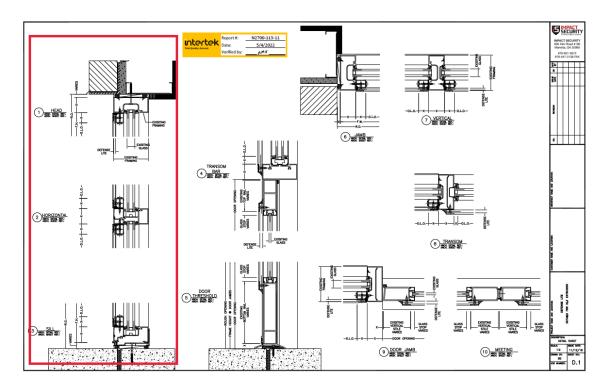
DRAWINGS

Drawings of the test specimen are included in Section 12.

FRAME
SIZE	48" by 78"
THICKNESS	4-1/2"
CORNERS	Butted
FASTENERS	Screws
SEAL METHOD	Sealant
MATERIAL	Aluminum
REINFORCEMENT	N/A
THERMAL BREAK MATERIAL	N/A
DAYLIGHT OPENING SIZE	34-1/2" by 73-1/4

EXTERIOR SHEET
MEASURED THICKNESS	0.332"
MATERIAL	Polycarbonate
AIRSPACE	1.625"
	INTERIOR SHEET
MEASURED THICKNESS	0.225"
MATERIAL	Tempered
GLAZING METHOD	Exterior
GLAZING MATERIAL	EPDM
GLAZING BEAD MATERIAL	Aluminum
