BALLISTICS / FORCED-ENTRY RESISTANCE TEST REPORT

ASTM F3561 AND ASTM F588 TESTING ON FIXED WINDOW COMPOSITIONS (*RIOTLITE*)

S1432.01-119-12 R0

TEST REPORT FOR IMPACT SECURITY, LLC

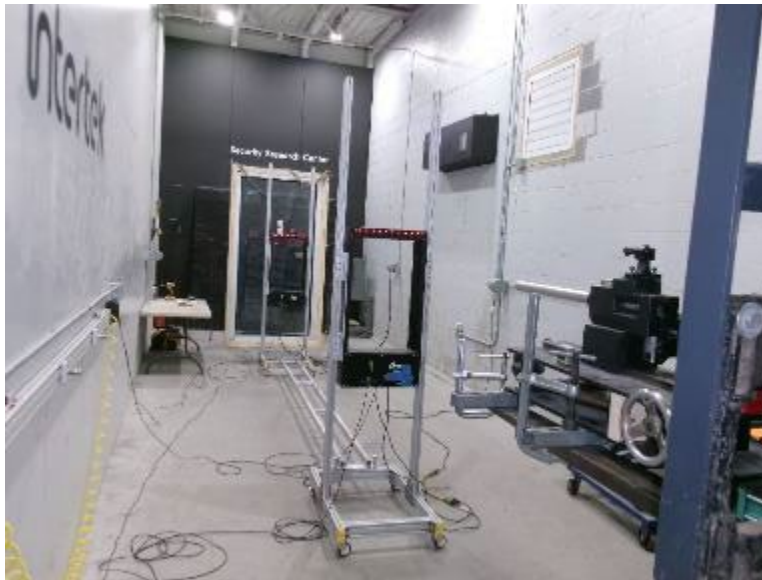
Photo No. 1
Ballistic Range Set-up

The sample was rigidly mounted for ballistics resistance testing. The muzzle of the test firearm was set at 25 feet from the sample at zero-degree ($\pm 3^\circ$) obliquity. Ballistic screens were set at 5 feet and at 20 feet from the muzzle of the firearm. Test ammunition was 5.56 mm NATO, 55 grain, copper jacket lead core, which conformed to ASTM F3561, Table 1 requirements with the exception that the velocity of some projectiles was below the required velocity (3357-3423 fps). In the instances where the velocity was below the required minimum, weakening of the specimen was still achieved as displayed by penetration of the specimen. Shot locations were per Figure 4 of ASTM F3561 for glazing and panels.

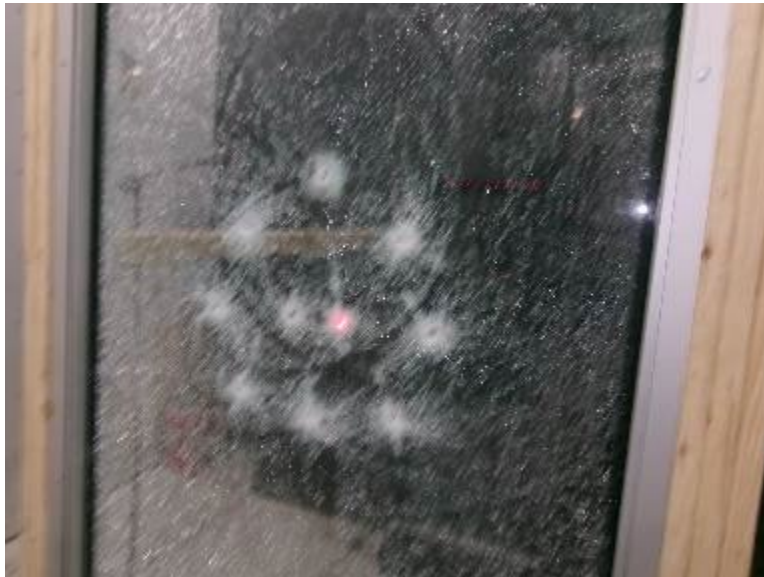
Photo No. 4

Test Series No. 1/Specimen No. 1, Post-Test (Attack Side) (Ballistics)

SHOT NO.	SHOT LOCATIONS ¹	SPECIMEN TEMP. (°F)	VELOCITY (fps)	RESULTS
1	N	61	3316	Penetrated
2	S		3322	Penetrated
3	W		3386	Penetrated
4	E		3335	Penetrated
5	NW		3397	Penetrated
6	SW		3331	Penetrated
7	NE		3350	Penetrated
8	SE		3374	Penetrated
9	C1		3344	Penetrated
10	C2		3350	Penetrated

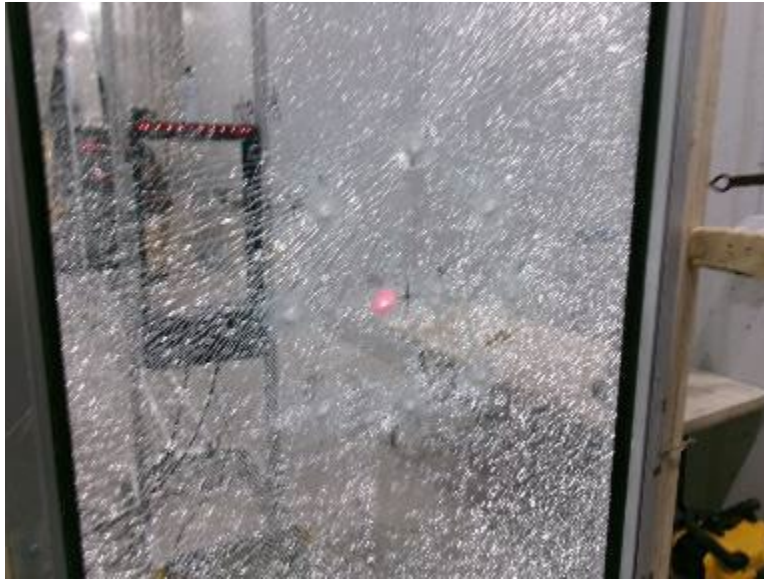
Photo No. 5

Test Series No. 1/Specimen No. 1, Post-Test (Protected Side) (Ballistics)

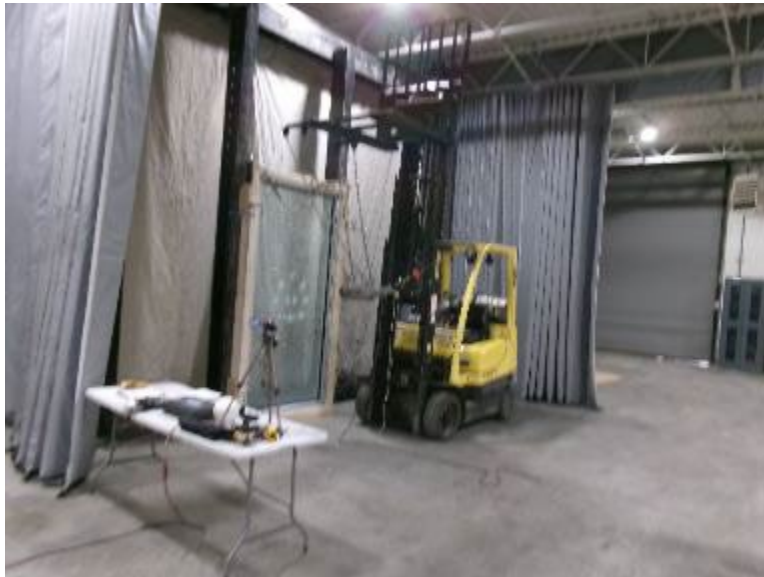
Forced Entry Test Set-up

Impacts were delivered to the product using an impact ram as specified in ASTM F3561, Section 6.6. The product was rigidly anchored to a supporting test frame and the impacts were delivered to the specimen as per ASTM F3561, Section 16. Two impacts were delivered to the center of the specimen for each drop height beginning at a height of 0.5 ft and increasing in increments of 0.5 ft until failure occurred. The potential energy delivered at each drop height is detailed in the following table:

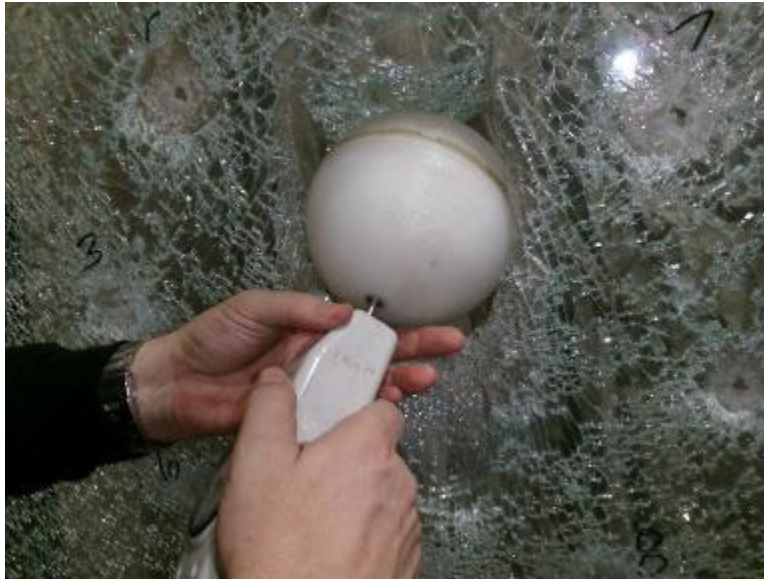
Photo No. 9

Test Series No. 1/Specimen No. 1, Post-Test (Attack Side) (Forced Entry) Level 4.1

LEVEL	NUMBER OF IMPACTS	SPECIMEN TEMP. (°F)	DROP HEIGHT (ft.)	PASS/FAIL	RESULTS
1	2	66	0.50	Pass	1 st Impact: No change 2 nd Impact: No change
2	2		1.00	Pass	1 st Impact: No change 2 nd Impact: No change
3	2		2.00	Pass	1 st Impact: No change 2 nd Impact: Tear between shot locations C1 and C2; A vertical tear was also observed at C2
4	1		2.50	Fail	1st Impact: The nose cone passed through the glazing to the point where the gasket was visible on the protected side

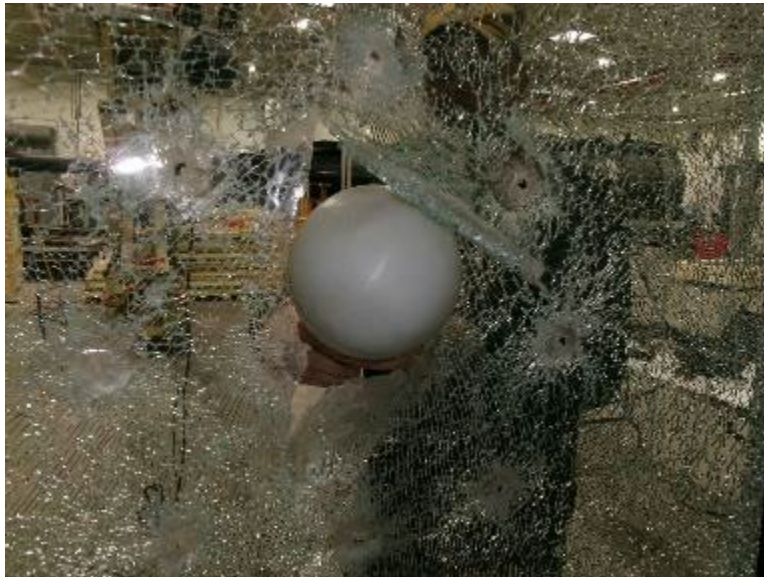
Photo No. 10

Test Series No. 1/Specimen No. 1, Post-Test (Protected Side) (Forced Entry) Level 4.1

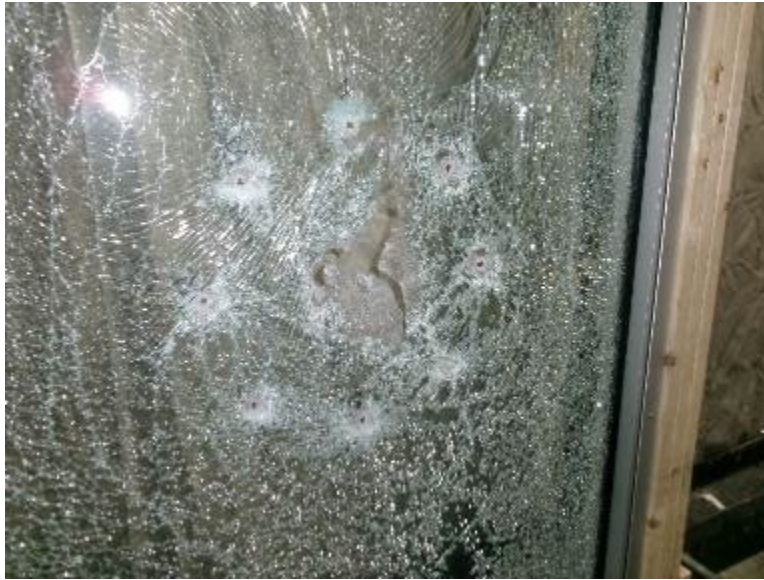
Photo No. 17

Test Series No. 1/Specimen No. 2, Post-Test (Attack Side) (Forced Entry) Level 4.2

LEVEL	NUMBER OF IMPACTS	SPECIMEN TEMP. (°F)	DROP HEIGHT (ft.)	PASS/FAIL	RESULTS
1	2	64	0.50	Pass	1 st Impact: No change 2 nd Impact: No change
2	2		1.00	Pass	1 st Impact: No change 2 nd Impact: No change
3	2		1.50	Pass	1 st Impact: No change 2 nd Impact: Small tear started at shot location C2
4	2		2.00	Fail	1 st Impact: Tear at C2 grew larger 2nd Impact: The nose cone passed through the glazing to the point where the gasket was visible on the protected side

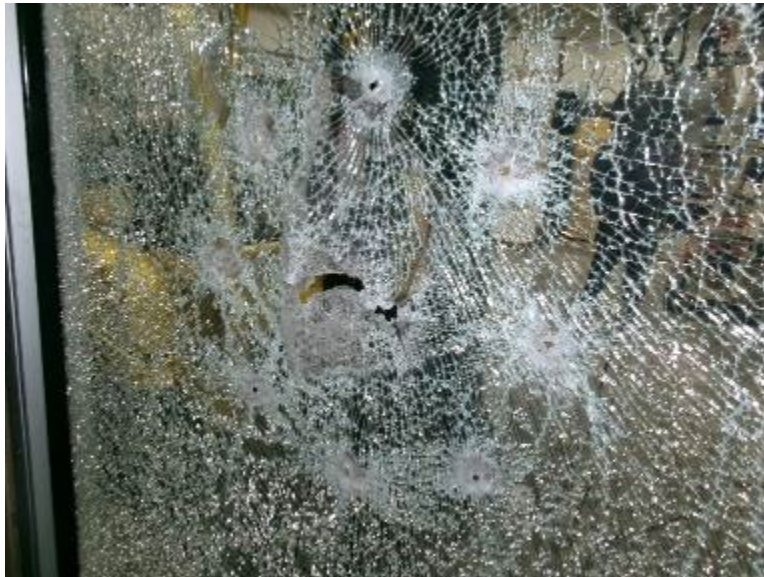
Photo No. 18

Test Series No. 1/Specimen No. 2, Post-Test (Protected Side) (Forced Entry) Level 4.2

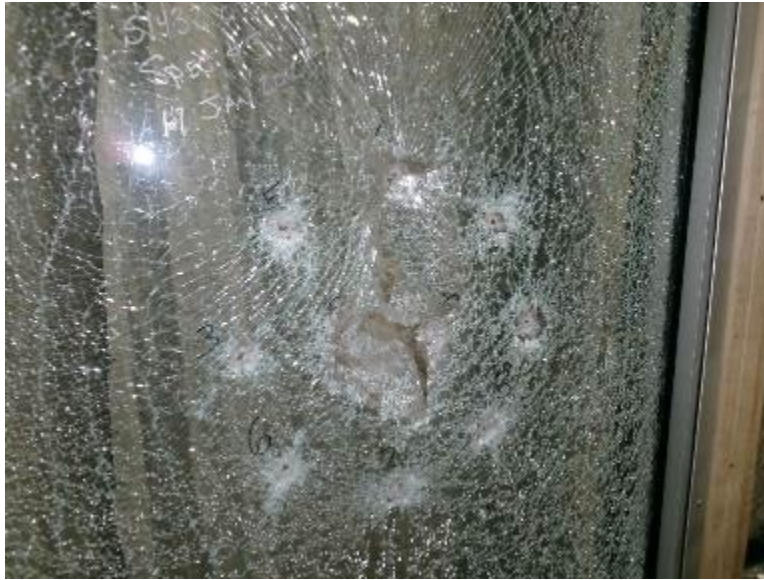
Photo No. 25

Test Series No. 1/Specimen No. 3, Post-Test (Attack Side) (Forced Entry) Level 4.2

LEVEL	NUMBER OF IMPACTS	SPECIMEN TEMP. (°F)	DROP HEIGHT (ft.)	PASS/FAIL	RESULTS
1	2	66	0.50	Pass	1 st Impact: No change 2 nd Impact: No change
2	2		1.00	Pass	1 st Impact: No change 2 nd Impact: No change
3	2		2.00	Pass	1 st Impact: No change 2 nd Impact: Tear between shot locations C1 and C2, approximately 1-1/2 in
4	2		2.50	Fail	1 st Impact: Impactor penetrated specimen but the gasket was not visible on the protected side and the test shape would not pass through with 4 lbs of force 2 nd Impact: The nose cone passed through the glazing to the point where the gasket was visible on the protected side

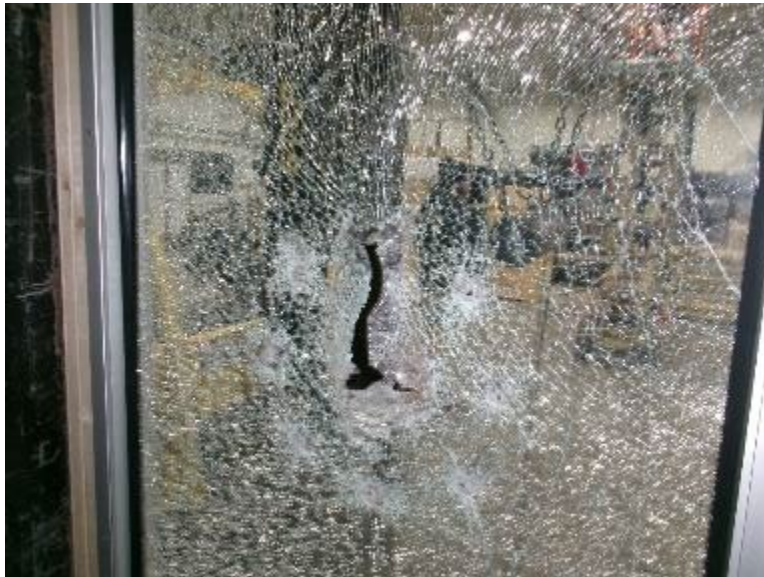
Photo No. 26

Test Series No. 1/Specimen No. 3, Post-Test (Protected Side) (Forced Entry) Level 4.2

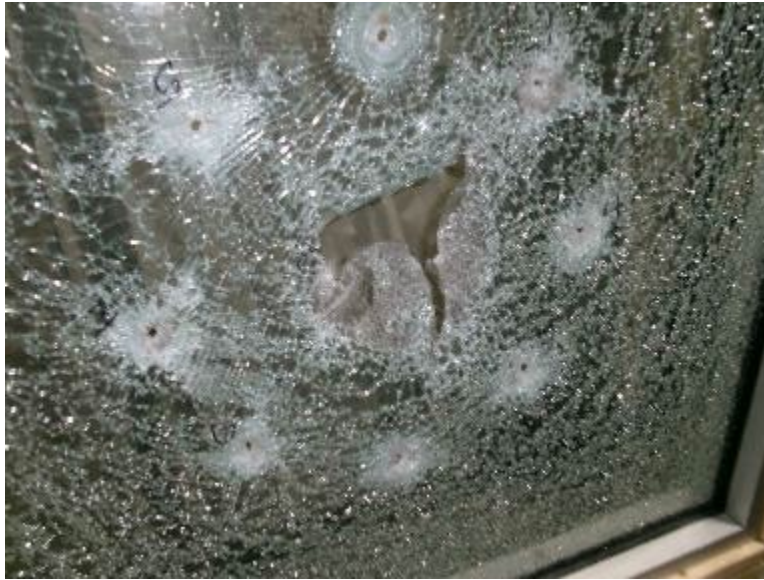
Photo No. 33

Test Series No. 2/Specimen No. 1, Post-Test (Attack Side) (Forced Entry) Level 4.1

LEVEL	NUMBER OF IMPACTS	SPECIMEN TEMP. (°F)	DROP HEIGHT (ft.)	PASS/FAIL	RESULTS
1	2	64	0.50	Pass	1 st Impact: No change 2 nd Impact: No change
2	2		1.00	Pass	1 st Impact: No change 2 nd Impact: No change
3	2		2.00	Pass	1 st Impact: No change 2 nd Impact: Tear at C2 approximately 3-1/2 in
4	1		2.50	Fail	1st Impact: The nose cone passed through the glazing to the point where the gasket was visible on the protected side

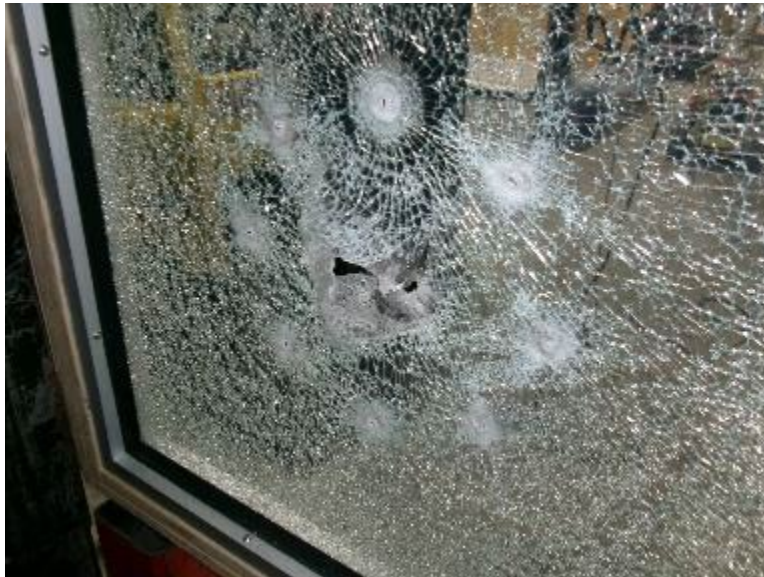
Photo No. 34

Test Series No. 2/Specimen No. 1, Post-Test (Protected Side) (Forced Entry) Level 4.1

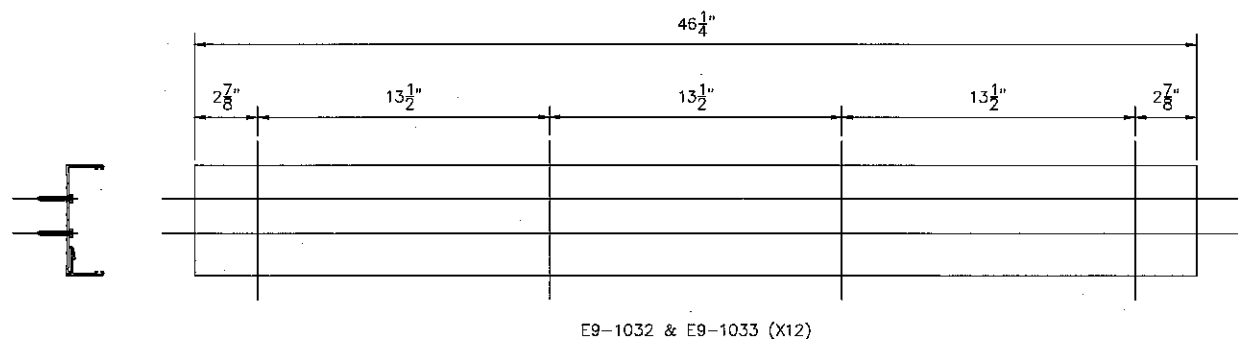
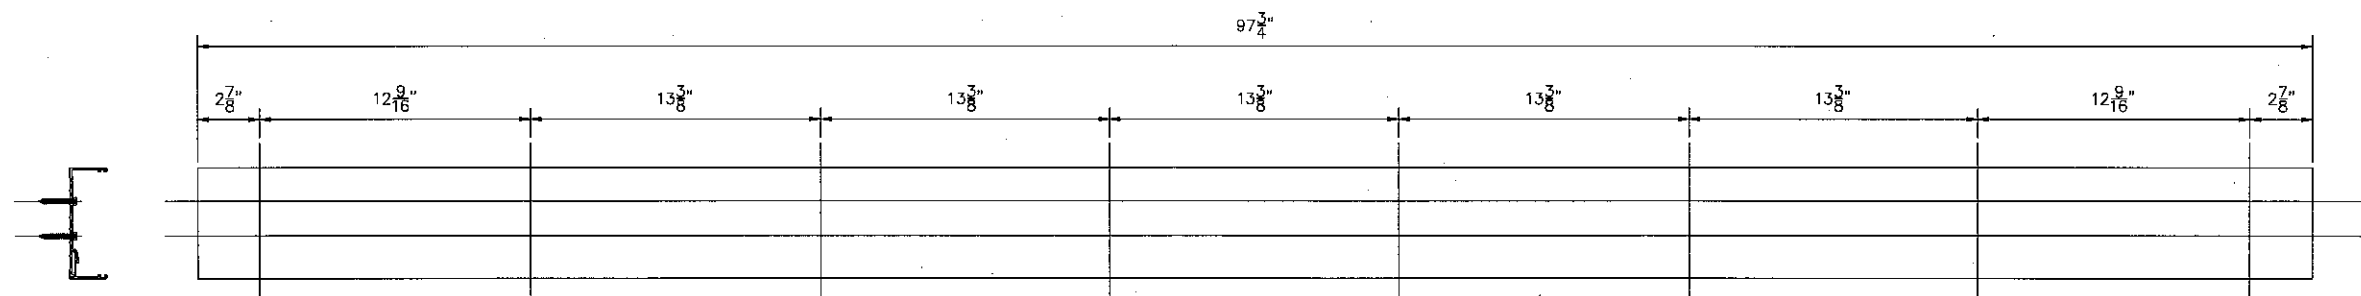
E9-1032 & E9-1033 (X12)

DESCRIPTION:
RECEPTOR CUT SHEET
SCALE:
1"=1'-0"
ISSUE DATE:
01-14-25
DRAWN BY:
CDD
SHEET NO.:
401
JOB NUMBER:

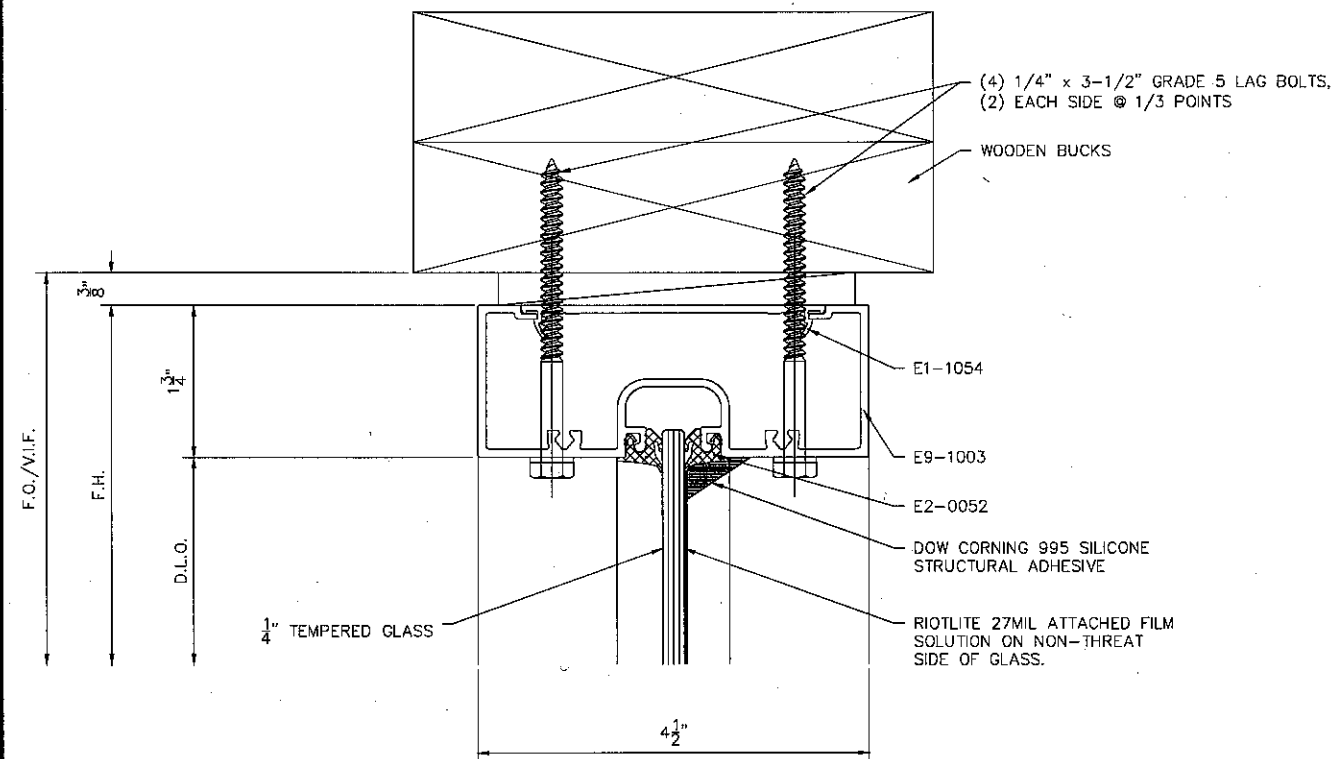
1 HEAD DETAIL
SCALE: FULL
ARCH. REF.: N/A

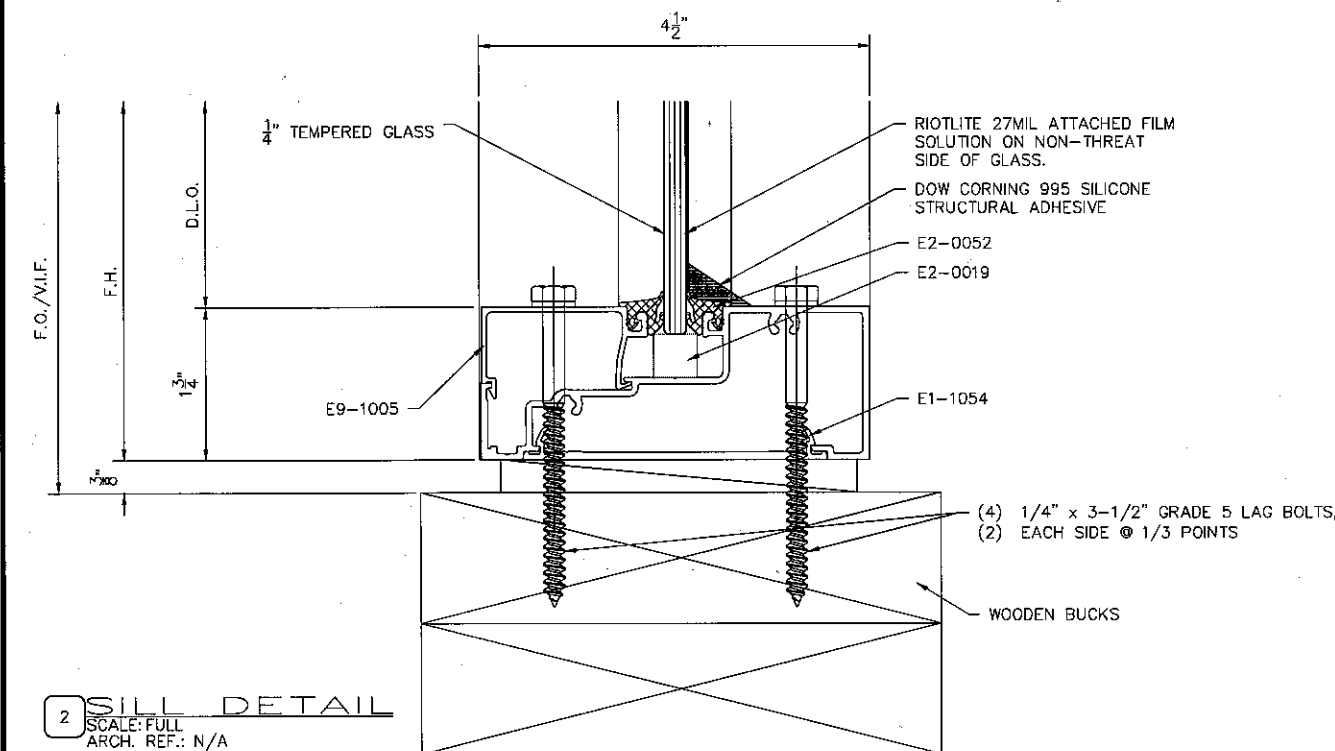
2 SILL DETAIL
SCALE: FULL
ARCH. REF.: N/A

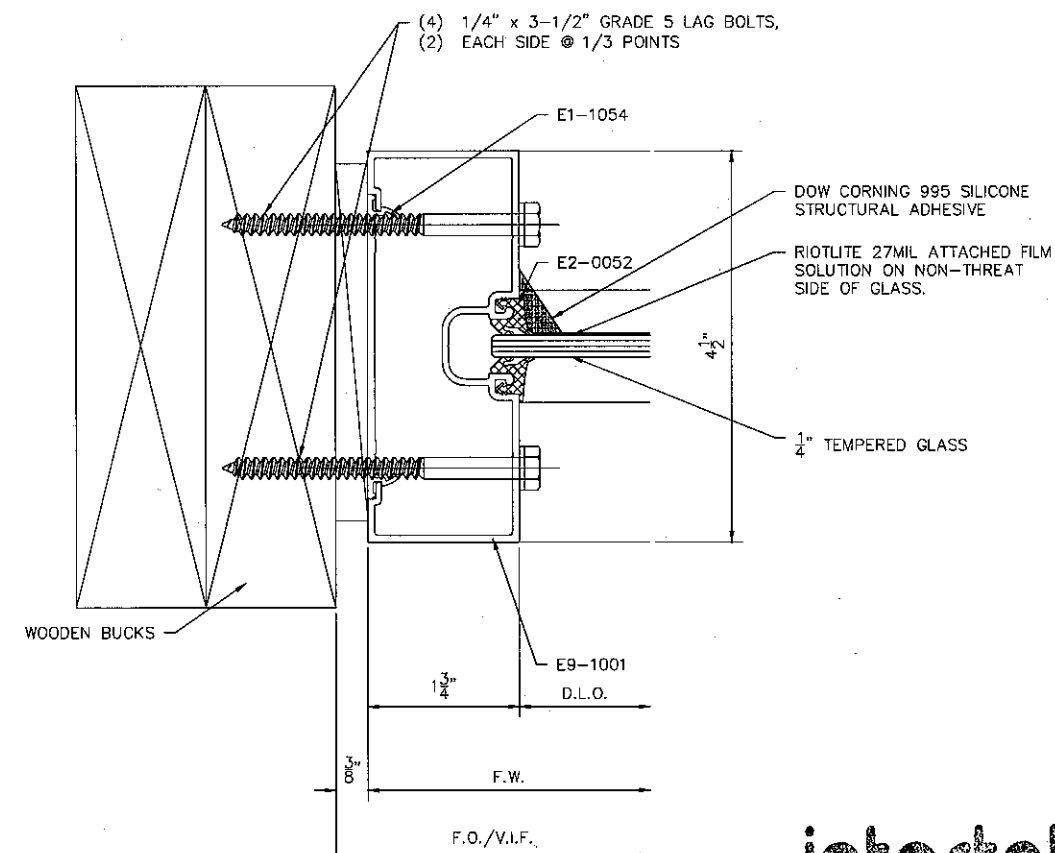
3 JAMB DETAIL
SCALE: FULL
ARCH. REF.: N/A
