**Figures 8a-8e: Corner Option Details**

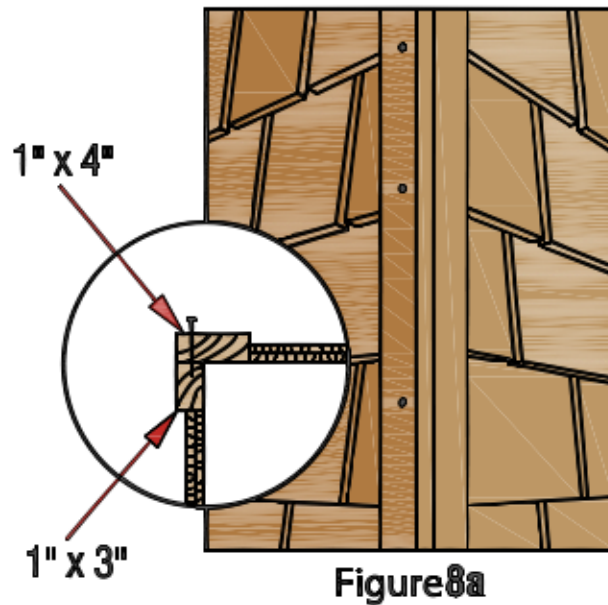
Figure 8a

| a) Certi-label® Western Cedar shingles butted against corner boards | c) Mitered corner |

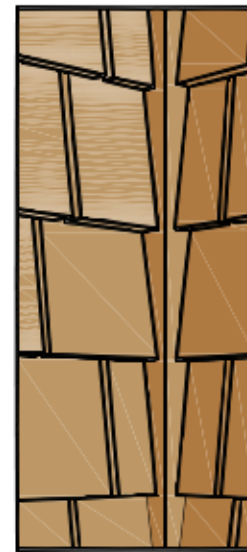
Figure 8b

| b) Certi-label® Western Cedar shingles butted against square wood strip, flashing behind | d) Laced inside corner with flashing behind inside strip on corner |

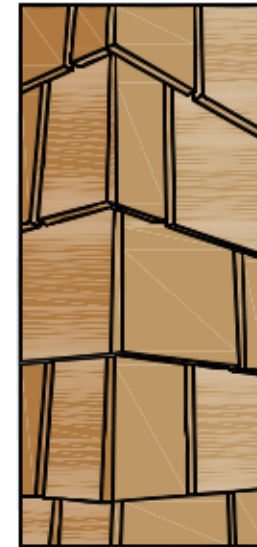
Figure 8e

| | e) Alternated laced outside corner |
