**SOUND TRANSMISSION LOSS TEST REPORT NO. TL09-441**

CLIENT: **AMSCO Windows**  
1880 South 1045 West  
P.O. Box 25368  
Salt Lake City, Utah 84125

The test specimen was an AMSCO VS-1 vinyl Filler Picture Window assembly. The specimen was installed by screwing the nailing fin around the entire perimeter to the wood edge of the test chamber opening. The specimen was sealed into the test chamber opening with latex caulking around the entire perimeter on the source room side and a heavy duct seal putty around the entire perimeter on the receive room side. The glazing consisted of a 1 inch (25.4 mm) dual glazed unit which was 1/8 inch (3.2 mm) double strength glass, 11/16 inch (17.5 mm) air space, and 3/32 inch (2.4 mm) single strength glass. The unit was glazed into the frame using glazing tape and a vinyl snap in bead. The net outside frame dimensions of the window assembly were 71-1/2 inches (1.82 m) wide by 47-1/2 inches (1.21 m) high by 3 inches (76 mm) deep. The overall weight of the assembly was 73 lbs. (33.1 kg) for a calculated surface density of 4.3 lbs./ft<sup>2</sup> (21 kg/m<sup>2</sup>). The two weep holes were normal with covers.

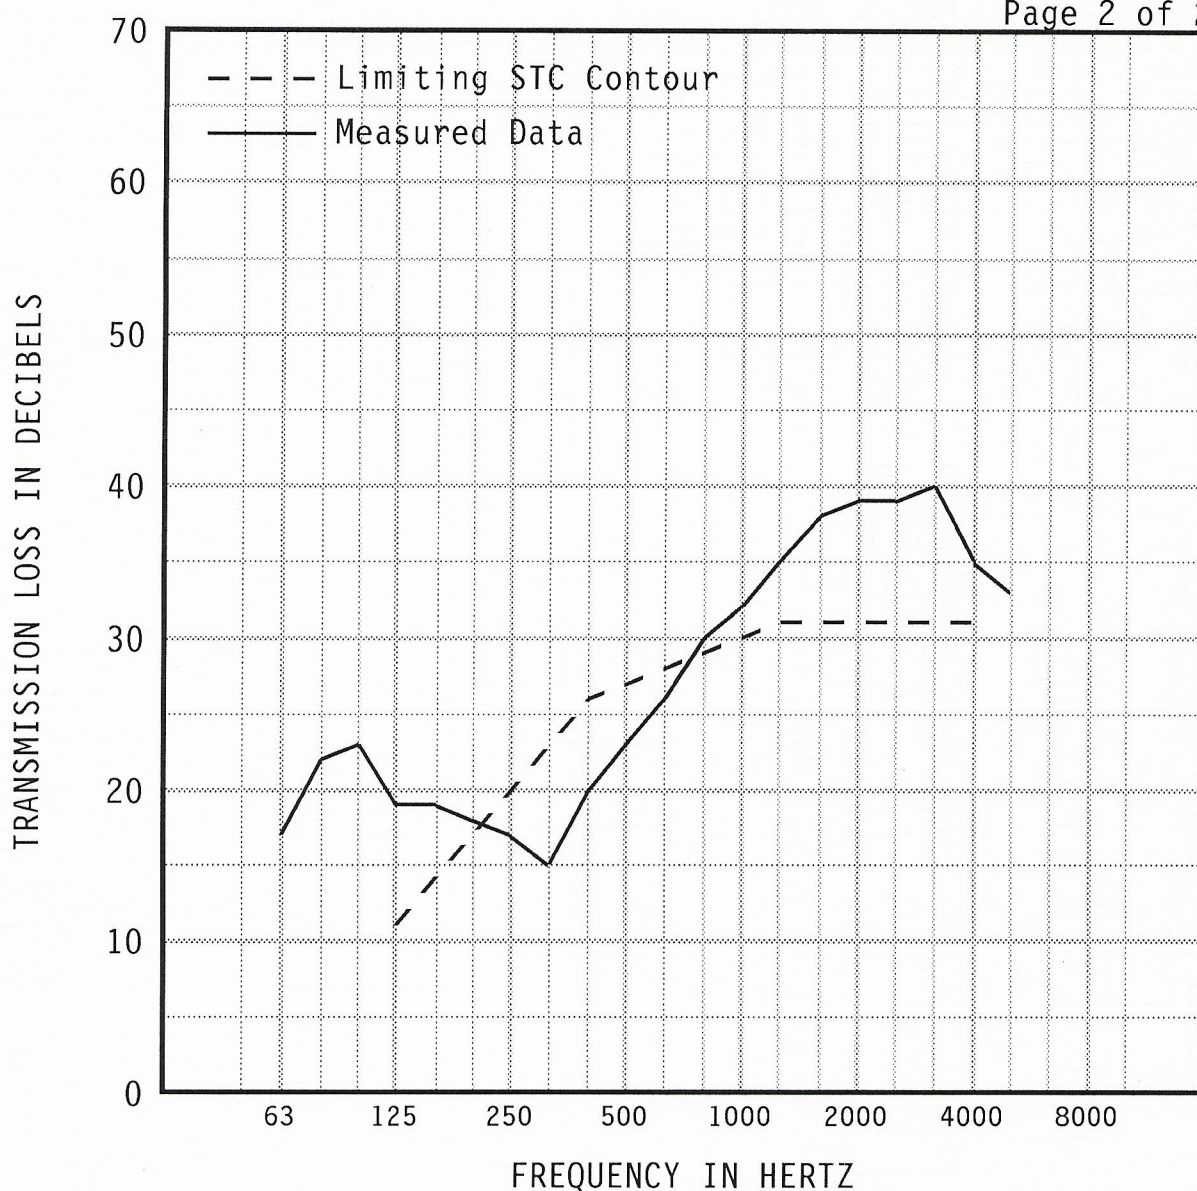
1/3 OCT BND CNTR FREQ	63	80	100	125	160	200	250	315	400	500
TL in dB	17	22	23	19	19	18	17	15	20	23
95% Confidence in dB deficiencies	1.42	1.92	2.07	1.47	0.89	0.76	0.80 (3)	0.52 (8)	0.36 (6)	0.38 (4)
1/3 OCT BND CNTR FREQ	630	800	1000	1250	1600	2000	2500	3150	4000	5000
TL in dB	26	30	32	35	38	39	39	40	35	33
95% Confidence in dB deficiencies	0.29 (2)	0.44	0.38	0.39	0.36	0.56	0.55	0.31	0.32	0.50
EWR 28	OITC 23	Specimen Area: 16.99 sq.ft. Temperature: 73.8 deg. F Relative Humidity: 44 % Test Date: 11 August 2009								STC 27 (23)

One-third octave band sound transmission loss values are plotted and tabulated on the attached sheet. ASTM minimum volume requirements are met at 80 Hz and above. The Sound Transmission Class rating determined in accordance with ASTM E 413-04 was STC-27.
