### SOUND TRANSMISSION LOSS TEST REPORT NO. TL12-319

Amsco

The test specimen was an Amsco V91 Series vinyl picture window assembly. The specimen was installed by screwing the nailing fin around the entire perimeter to the wood edge of the test chamber opening. The assembly was sealed into the test chamber opening with latex caulking under the nailing fin and a heavy duct seal putty around the entire perimeter on the receiving room side. The glazing consisted of a 25.4 mm (1 inch) dual glazed unit which was 3 mm (1/8 inch) double strength glass, 17.4 mm (11/16 inch) air space, and 5 mm (3/16 inch) monolithic glass. The unit was glazed into the frame using glazing tape and vinyl snap in bead. The net outside frame dimensions of the window assembly were 1.82 m (71-1/2 inches) wide by 1.21 m (47-1/2 inches) high by 66.7 mm (2-5/8 inches) deep. The overall weight of the assembly was 45.4 kg (100 lbs.) for a calculated surface density of 20.7 kg/m² (4.24 lbs./ft²).

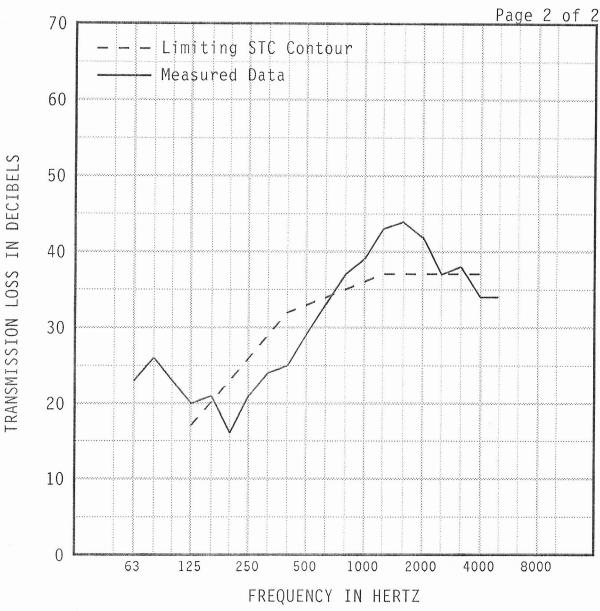
Report No. TL12-319

1/3 OCT BND CI	NTR FREQ	63	80	100	125	160	200	250	315	400	500
TL in dB 95% Confidence deficiencies		*23 1.42	26 1.92	23 2.07	20 1.47	0.89	16 0.76 (7)	21 0.80 (5)	24 0.52 (5)		29 0.38 (4)
1/3 OCT BND CI	NTR FREQ	630	800	1000	1250	1600	2000	2500	3150	4000	5000
TL in dB 95% Confidence deficiencies		33 0.29 (1)	37 0.44	39 0.38	43	0.36	42 0.56	37 0.55 (0)	38 0.31	34 0.32 (3)	34
EWR OITC  * Minimum estimate of transmission loss. Measurement limited by filler wall. Actual TL will be equal to or greater than value reported.  * Minimum estimate of transmission loss. Specimen Area: 23.59 sq.ft.  Temperature: 73.4 deg. F Relative Humidity: 40 %											STC 33 (32)
than value reported. Tost Dato: 16 May 2012

One-third octave band sound transmission loss values are plotted and tabulated on the attached sheet. ASTM minimum volume requirements are met at 80 Hz and above. The Outdoor-Indoor Transmission Class rating determined in accordance with ASTM E 1332-90(2003) was OITC-26. The Sound Transmission Class rating determined in accordance with ASTM E 413-04 was STC-33.
